Copper deposits in power pressure equipment – Problems in operation and maintenance

Paweł Gawron

Characteristics of the power unit under examination

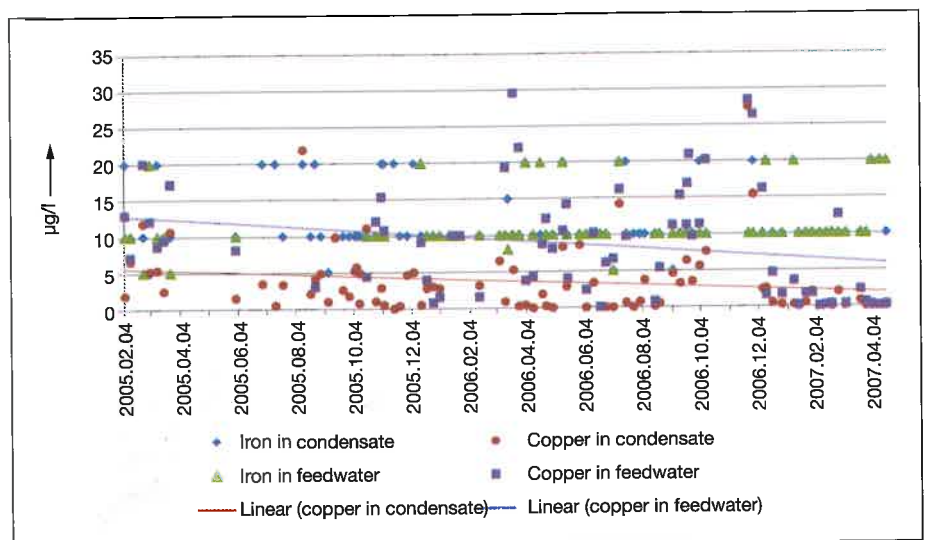
Figure 1. Iron and copper contents in condensate and feedwater

The initial guidelines concerning the quality of the working agent in the water-steam cycle of the unit are presented in Table 1. In the majority of cases the physical-chemical conditions maintained in the water-steam cycle were satisfying the above recommendations. The only significant deviation was found with copper compounds whose contents in condensate and feedwater frequently exceeded the recommended value of 3 µg/dm³, Figure 1.

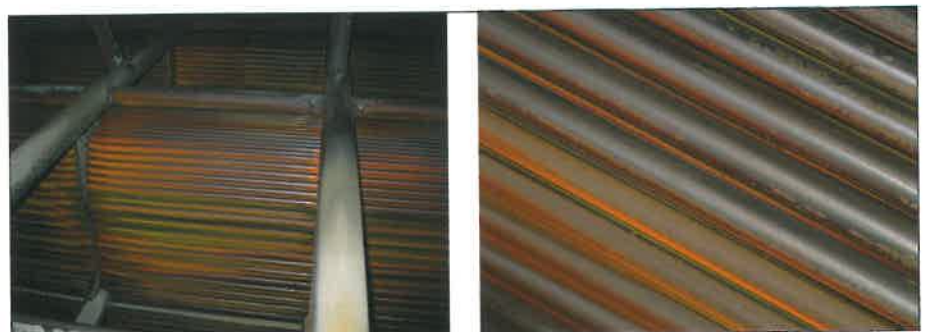
Figure 2. Condenser steam side

Along with the analyses, the condenser tubing from the steam side (Figure 2) and tube bundles of the LP regenerative heaters from the feedwater side (Figure 3) were visually inspected for surface condition and found free from any characteristic corrosion/erosion damage.

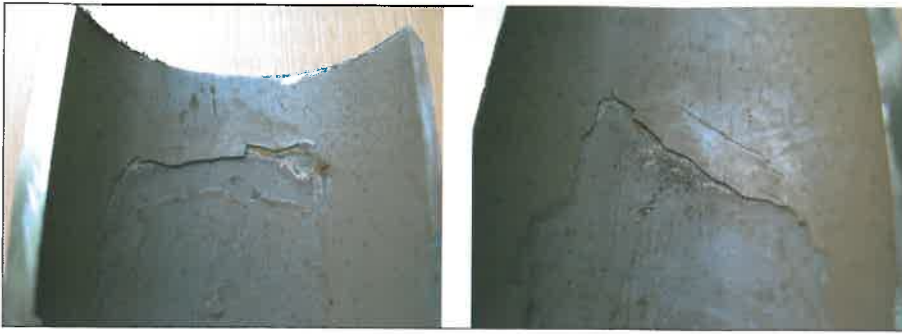
The internal surfaces of the tubes directed towards the furnace (fire side) were covered with the layer of grey-brown deposits 0.5 to 0.6 mm in thickness which was exfoliating and coming off the metal in the form of flakes (Figure 4). Corrosion pitting was found on the surfaces under the deposits. The pitting was filled with the deposits precipitated during an intense evaporation of water and with corrosion products. The walls of the tubes from the fire side were found considerably thinned showing a minimum of 3.8 mm in comparison with the nominal dimensions (diameter 63.5 x 6.0 mm).

Figure 4. Boiler waterwall tube – flaky deposits on the internal surface

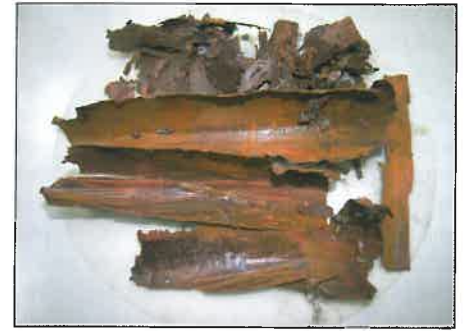
The amount of copper on the tubes from the boiler roof side was so large that even after chemical cleaning of the tubes their internal surfaces exhibited ample remainders of undissolved copper in the form of oblong flakes (Figure 5).

Figure 5. Flaky, copper deposits after chemical cleaning.

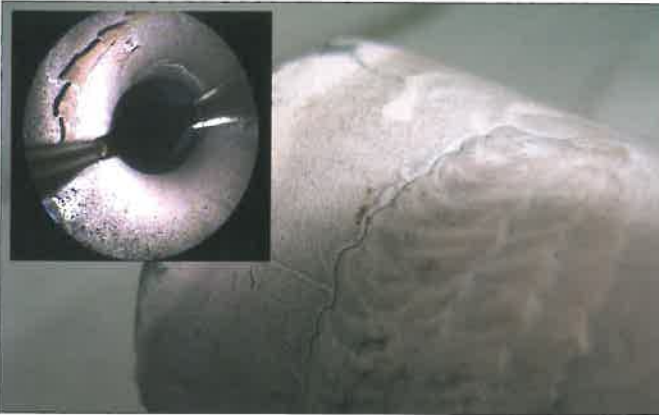
Figure 6. Flaky deposits on the internal surfaces of the tubes. Concentrations of molten copper on the perforation areas (a/b).

were oriented either circumferentially, along the overlay weld, or radially. Considerable amounts of flaky deposits were found on the internal surfaces of the tubes, showing well-marked clusters in the area of welds performed. Noticeable concentrations of molten copper were found within the perforation areas as well (Figure 6a and 6b). The deposits from the internal surfaces of the tubes were checked for chemical composition which indicated the contents of copper compounds

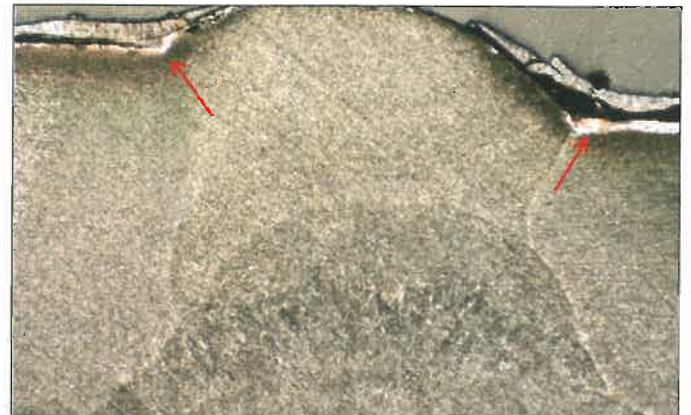
Figure 7. Copper fused into the surface layer of metal

ranging from 44 % to 66 % (Table 5). The surface of the weld was found to be covered with large amount of copper occurring not only in the deposit itself but also fused into the surface layer of metal (Figure 7).

The welding problems and consequent damage to the tubes subjected to the overlay welding were caused by copper contained in the deposits covering internal tube surfaces. Due to high temperatures during welding, copper

diffused into the tube wall metal along grain boundaries thus reducing the ductility of the heat affected zone, which resulted in brittle fractures. A similar phenomenon of precipitation hardening may occur with the steels in which copper contents exceeds 0.3%.

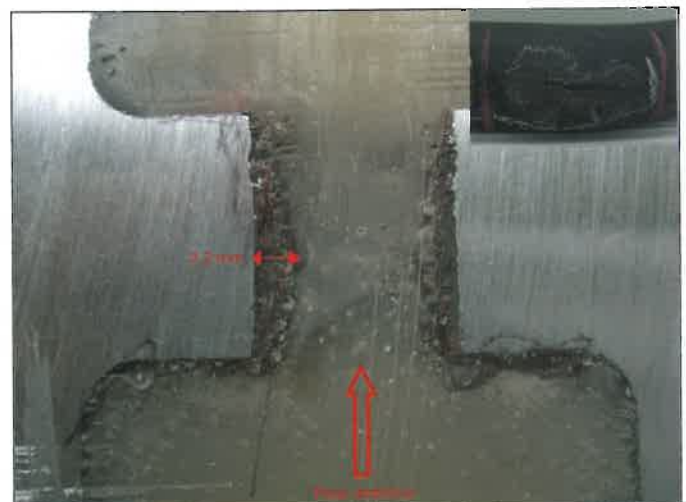
The objective of the orifices is to change the velocity of steam flow through the platens whereby its temperature on the superheater outlet drops thus improving the operating conditions of the tubes interconnecting the platens and outlet steam header. The damaged tube exhibited a narrow crack accompanied by "bulging" deformation. The crack was localised on the extrados of the bend and was accompanied by numerous small cracks running in parallel with it. A longitudinal polished section was prepared from the orifice showing the deposit layers up to 2.2 mm thick on the edges of the orifice bore whose nominal size was 11 mm (Figure 8).

The failure of the tube was caused by the overheating of its material due to the orifice bore being partly clogged by the deposits. The high degree of material degradation resulted from the operation at elevated temperatures, due to an insufficient heat transfer by steam.

Figure 8. Deposit layers on the edges of the orifice bore.
